## **Problem - Vise not working properly**

Vermeer Service team attended a D24X40 Series II machine wherein vise was not working in properly. The machine was attended by a Non-Vermeer person before Vermeer Visit and advised to change vise harness.

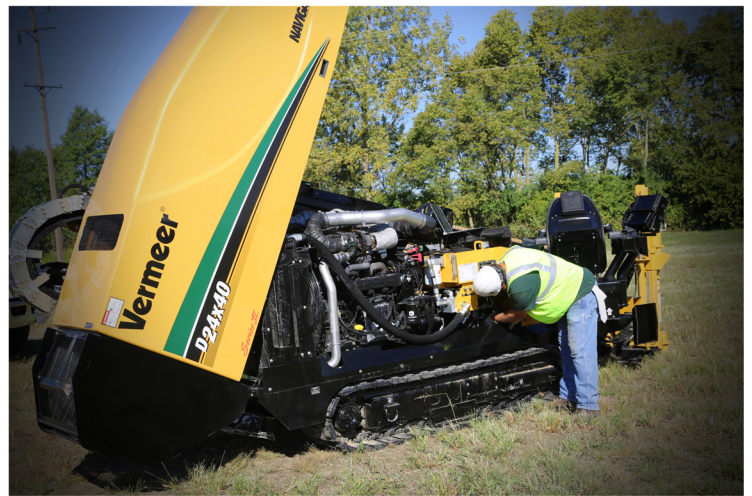
Vermeer service engineer during his visit to the machine, had discussion with the operator of the machine to understand history of the problem. As per operator, instead of changing the wire harness, their team had cleaned all the couplers and connectors on the harness, and it was working fine. The harness was in good condition as well. Vermeer Engineer then inspected all couplers fitting locations and position of vise harness as per the electrical schematic. It was found that vise power cartridge coupler was wrongly fit. Upon connecting the coupler in right way, the issue was resolved.

In this case, minor problem was portrayed as bigger problem by local personnel due to lack of knowledge. Vermeer team fixed this by adopting systematic approach towards the problem.
